# Tsunami-Seabed-Structure Interaction from Geotechnical and Hydrodynamic Perspectives

S. Sassa<sup>1</sup>

<sup>1</sup>Port and Airport Research Institute, Yokosuka, Japan

**ABSTRACT:** The paper reports some recent research advances on tsunami-seabed-structure interaction following the 2011 off the Pacific Coast of Tohoku Earthquake Tsunami, Japan. It presents a concise review of the latest research performed on the stability of breakwater foundation under tsunami by utilizing a geotechnical centrifuge and a large-scale hydro flume at Port and Airport Research Institute. I highlight here the role of tsunami-induced seepage in piping/boiling, erosion and bearing capacity decrease and failure of the rubble/seabed foundation. A comparison and discussion are made on the stability assessment for the design of tsunami-resistant structures on the basis of the results from both geo-centrifuge and large-scale hydrodynamic experiments.

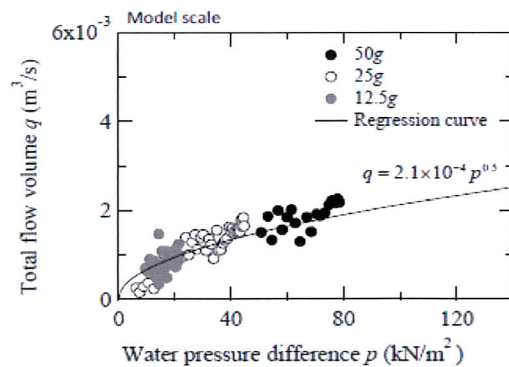
(a) Kamaishi model (Rock A)

(b) Omaezaki model (Rock B)

Figure 3 Verification of turbulent seepage flow field in a geo-centrifuge. Fig. 5a,b and Fig. B1 of Takahashi et al. (2014) are combined

and the seepage flow volume  $q$  through the mound that were measured under different gravities (Fig. 3a,b), show that  $q$  was proportional to a root of  $p$ , indicating that the seepage flow in the mound was indeed turbulent according to Eq. (1) described above.

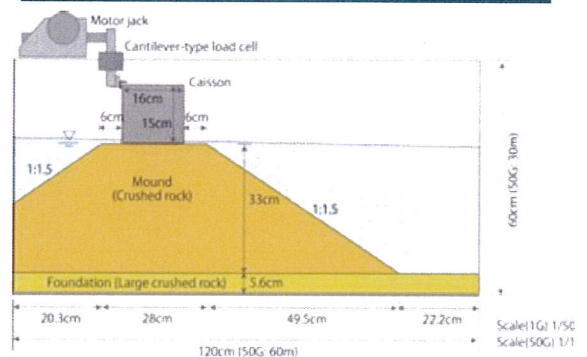
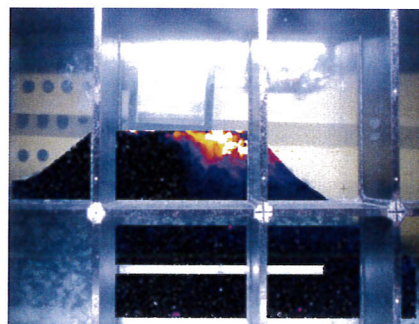
Figure 6 Model cross-sections used for clarifying the bearing capacity characteristics of rubble mounds of caissons. Fig. 11 and Fig. 13a of Takahashi et al. (2014) are combined. Deformed area is marked in red color

The bearing capacity decrease and failure characteristics of the rubble mounds of caissons were examined using the model cross-sections shown in Fig. 6. In order to control the horizontal loading toward the caisson and the seepage flow caused by tsunami independently, a vertical water stop wall was installed. It may be important here to note that the seepage direction was rather oriented

on the effect of the tsunami-induced seepage on the bearing capacity of the mound. The results of the horizontal loading test show that the deformed area was concentrated on the top shoulder of the mound, indicating the occurrence of strain localization in the limit state (Fig. 6). The results of the combined horizontal loading and

seepage flow test show that a bearing capacity failure took place, accompanying flow deformations of the mound (Fig. 7). The hydraulic gradient induced around the top shoulder of the mound was equal to  $i = 0.4$  in the Model B (Fig. 6). Note here that the failure did not take place under the same load without the seepage. In fact, the measured relationships between the horizontal load and displacement show that the bearing capacity of the mound decreased by approximately 30% due to the tsunami-induced seepage (Fig. 7).

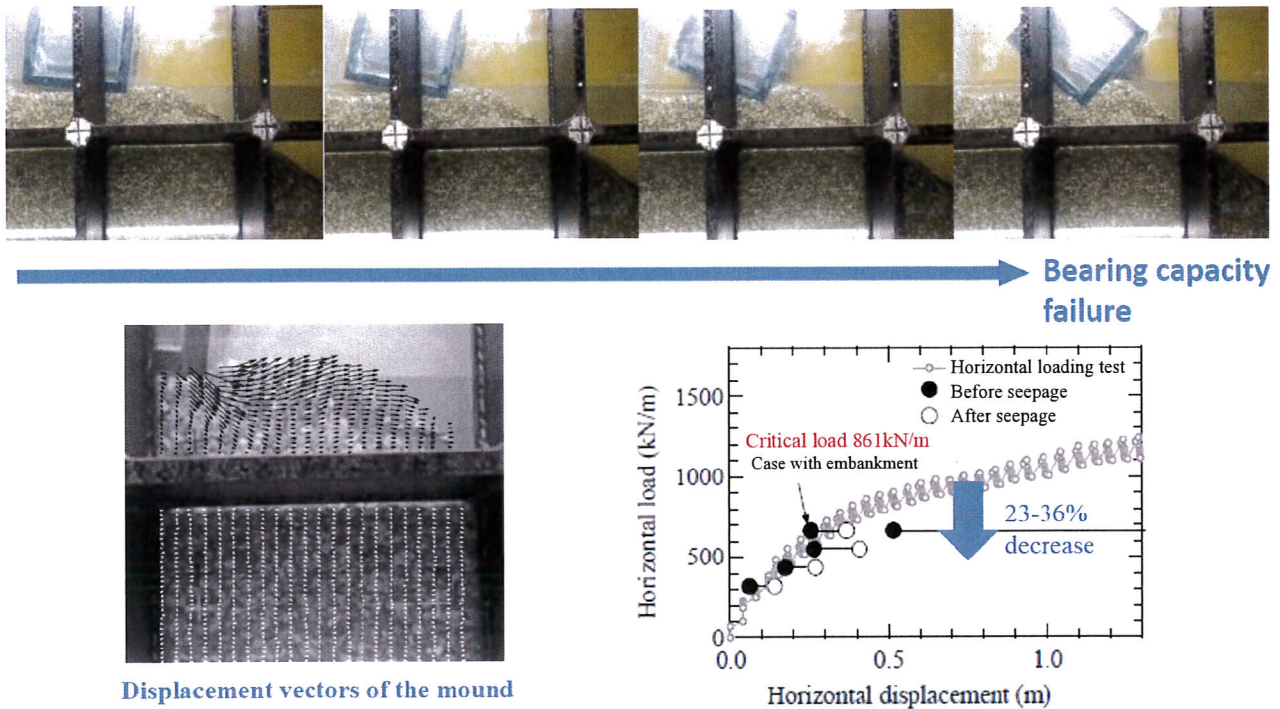
Horizontal loading + Seepage flow (model B)

Figure 7 Seepage-flow induced bearing capacity failure. Fig. 16b and Fig. 17 of Takahashi et al. (2014) are combined and descriptions are added

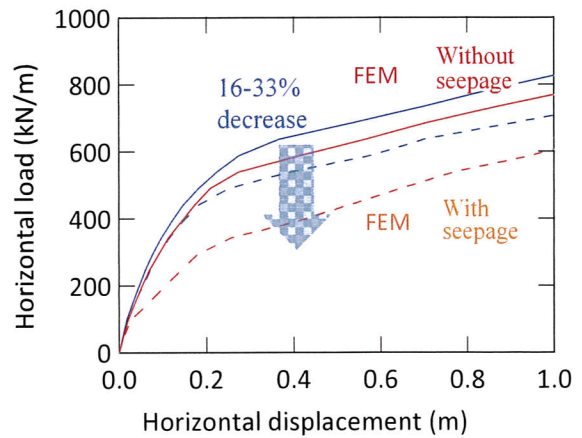
Excess pore pressure distributions

Deformation distributions

Figure 8 FEM analysis for reproduction: Pressure/Deformation distributions/Bearing capacity. Fig. 19b, Fig. 20 and Fig. 21b. of Takahashi et al. (2014) are combined and descriptions are added. The blue and red lines denote analyses with and without cohesion.

In order to confirm the above experimental finding and extend the knowledge to actual field conditions, the finite element analysis was conducted using the GeoFEM code developed at Port and Airport Research Institute. Although the seepage flow in the mound was turbulent, the analysis assumed Darcy flow adopting the linear relationship between the seepage flow velocity and the hydraulic gradient. As such, the material parameters involving the permeability coefficient were selected so as to yield the measured hydraulic gradient ( $i = 0.4$ ) in the top shoulder of the mounds, whose region proved to be important in light of the stability of the caisson. The numerical results show that the excess pore water pressure distributions, the deformation characteristics, and the decrease in the bearing capacity as measured in the experiments were adequately reproduced by the analysis (Fig. 8).

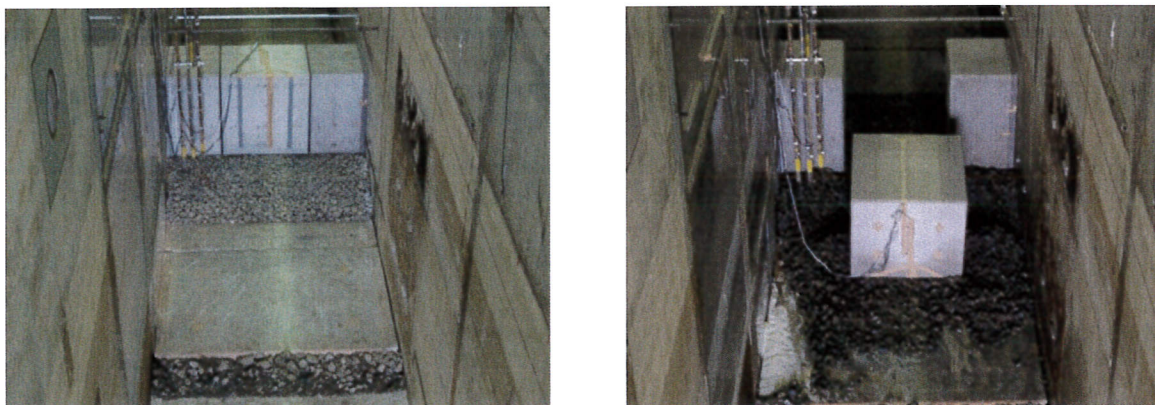
Figure 10 Large-scale hydro flume experiment of Arikawa and Shimosako (2013), showing views before and after the experiment. Caisson failed accompanying flow deformations of the rubble mound under tsunami

This section discusses a large-scale hydro flume study performed by Arikawa et al. (2013), in light of the geo-centrifuge study described above. For this purpose, I focus on the bearing capacity failure of caisson breakwaters. The hydro flume used was 184m long and 3.5m wide and 12m deep. Arikawa et al. (2013) modeled the Omaezaki breakwater with a 1/7.5 scaled model that was 40.98kN/m and 1.5m thick. With reference to Fig. 10, dummy caissons which were 10% heavier per 1m of width than the model caisson were installed at both ends of the channel. Water was discharged from the offshore side gate and taken in the shore side

gate of the flume, creating a water level difference between outside and inside of the caisson. The modeled water level difference was 4.5m on prototype scale. In order to prevent the occurrence of erosion of the sandy ground, a thin concrete plate was installed just underneath the rubble mound (Fig. 10). The experimental results show that the bearing capacity failure took place accompanying flow deformations of the mound (Fig. 10).
